Docket No. 217 – Development and Management Plan Inspection

Northeast Utilities Service Company Certificate of Environmental Compatibility and Public Need for the construction of a 345-kV electric transmission line and reconstruction of an existing 115-kV electric transmission line between Connecticut Light and Power Company's Plumtree Substation in Bethel, through the towns of Redding, Weston, and Wilton, and to the Norwalk Substation in Norwalk, Connecticut.

Date: September 20 and 22, 2006

Location: Overhead Line (Composite 345kV and 115kV Gallows Hill to Archers Lane,
345kV H-Frame Hoyts Hill to Gallows Hill, and Norwalk Section)

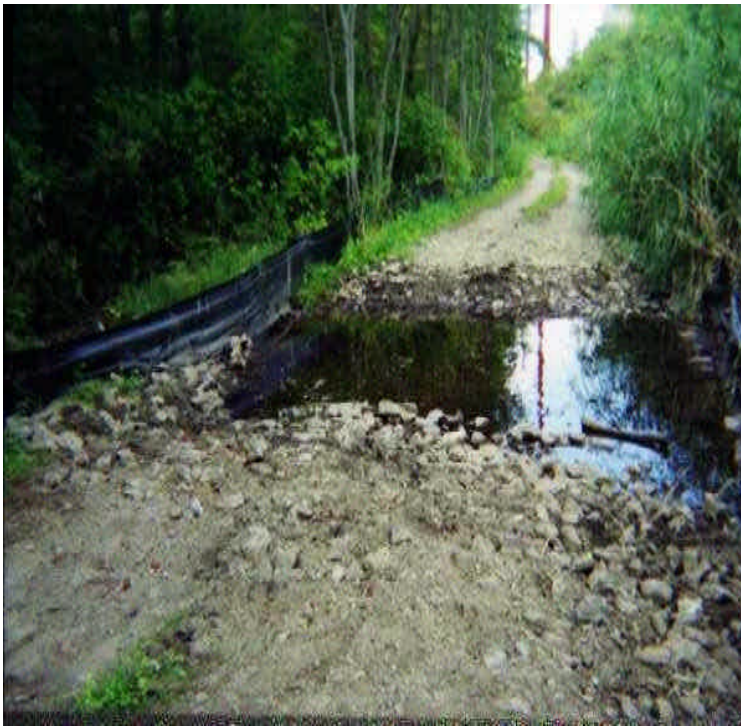
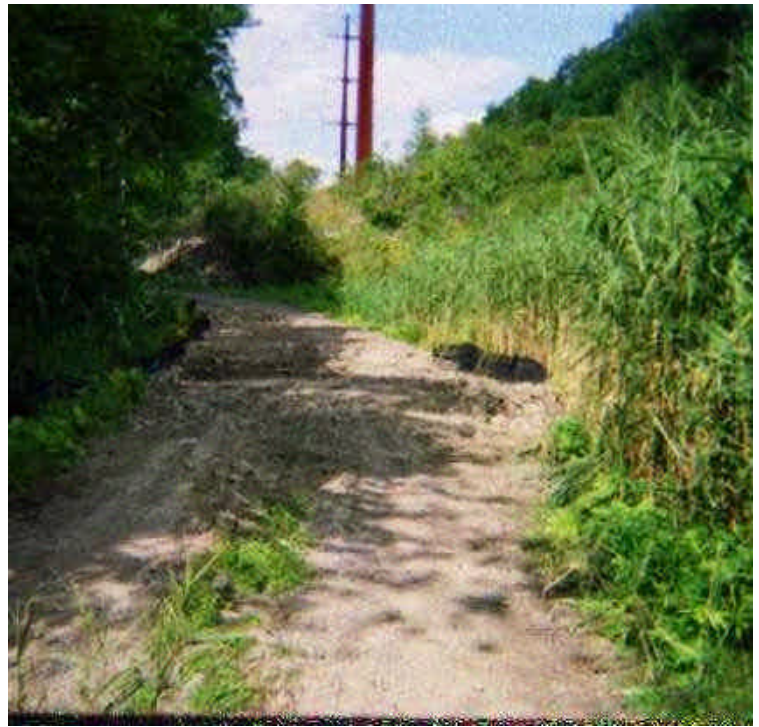
(Composite Section): Photo on the left shows the third wetland crossing in the ROW near Archers Lane. Stone and fabric have been removed from the ROW and the wetland crossing was restored. Photo on the right shows a 2nd area of this crossing being restored. 9/22/06.

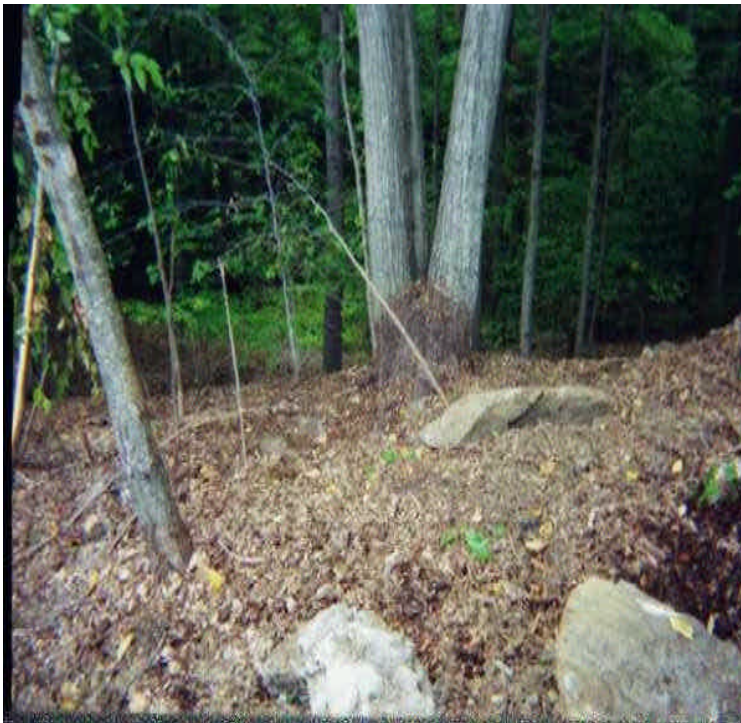
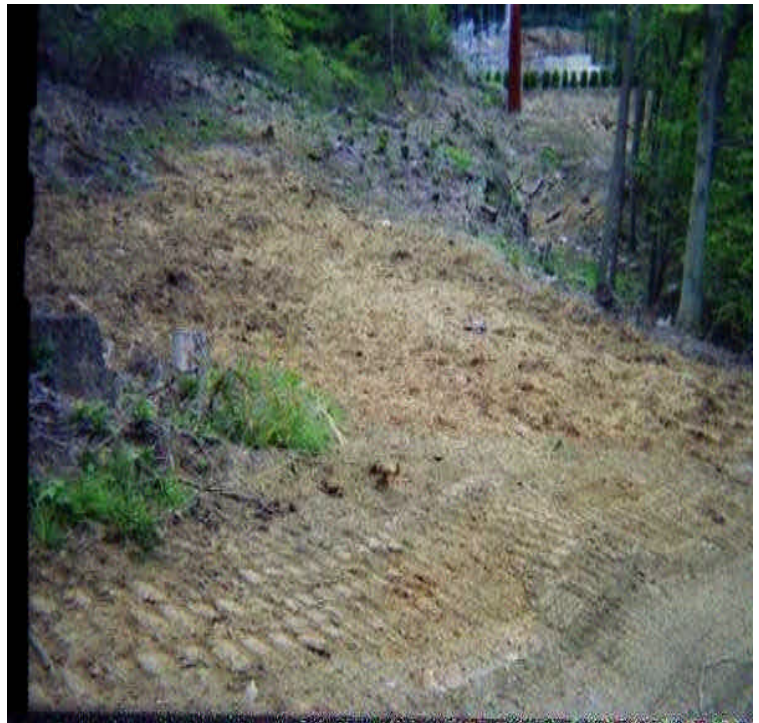
Photo on the left shows the area near structures #43-44 where the large pile of wood chips has been raked out. Wood chips have been spread within the ROW to a more appropriate depth. Photo on the right shows a restored area off the ROW near Archers Lane where a new water bar is directing flow. 9/22/06.

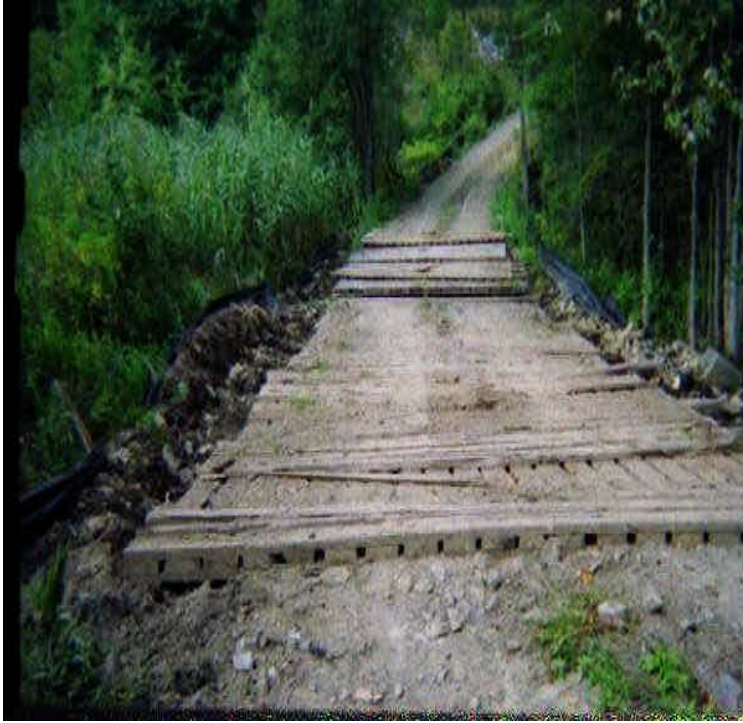
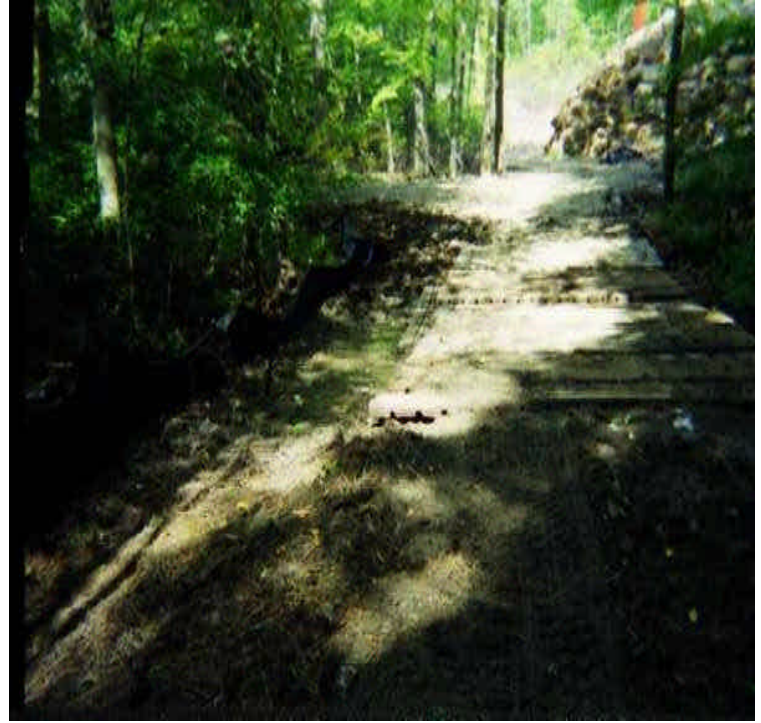
Photo on the left shows the second wetland crossing in the ROW near Archers Lane. Photo on the right shows the first wetland crossing. Stone and fabric have been removed from both crossings but swamp mats remain temporarily. 9/22/06.

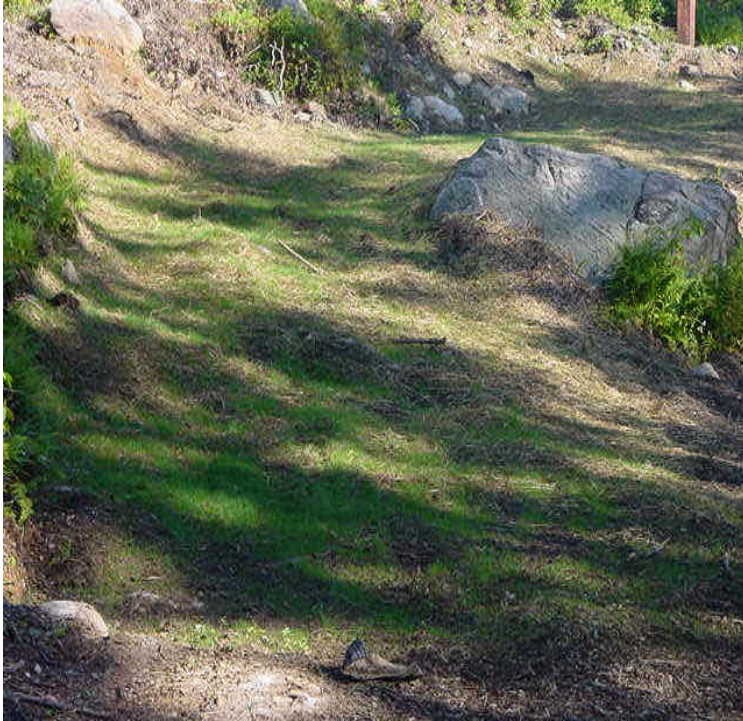
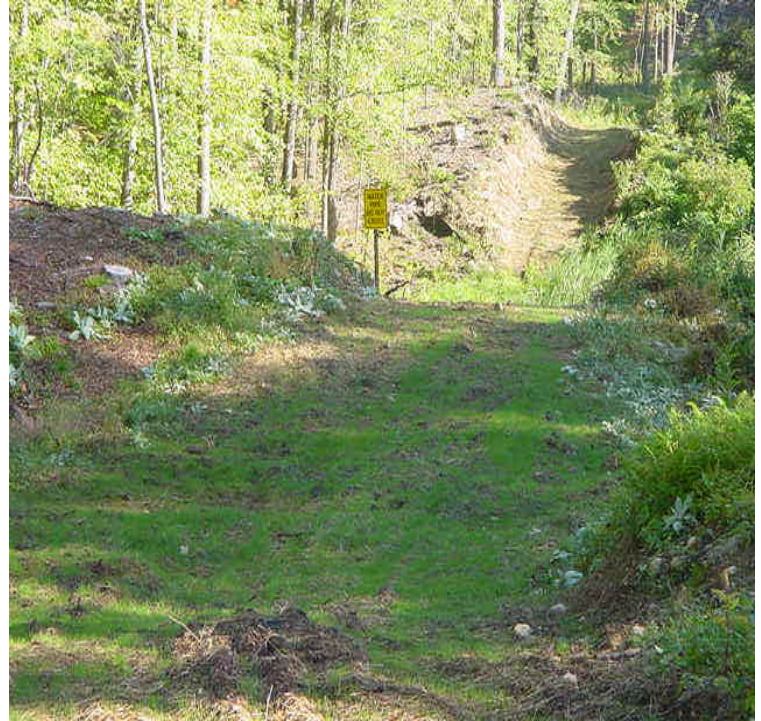
(345kV H-Frame) Photo on the left shows the restored area at structure #15 near Bethel Reservoir. Photo on the right shows the restored area at the wetland crossing between structures #10 and #11. Most areas along the Bethel Reservoir Section of ROW are re-vegetating. 9/20/06.

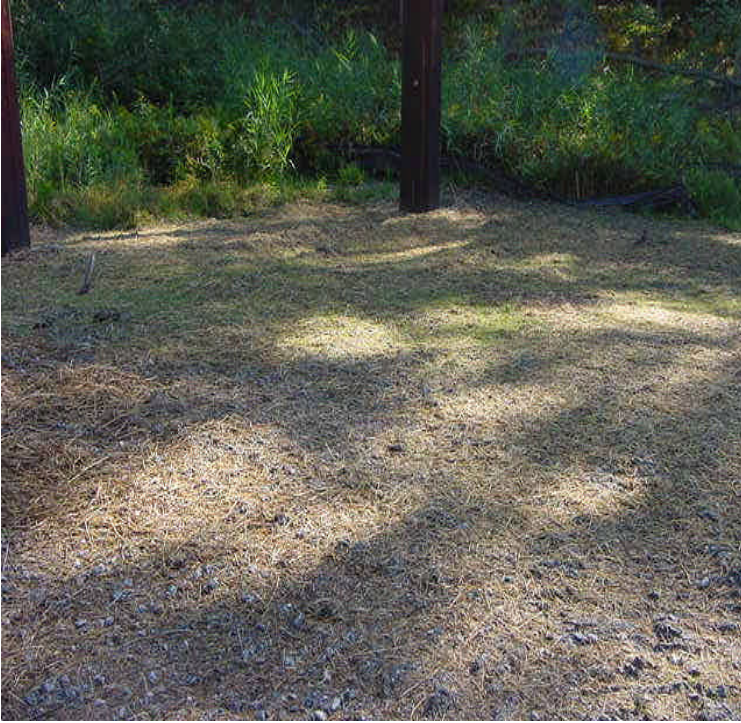
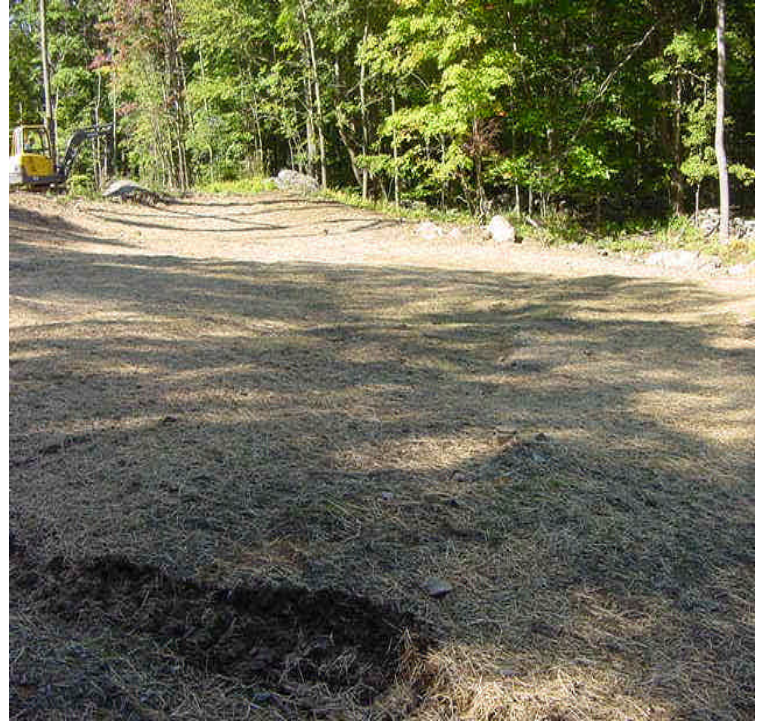
**Photo on the left shows a view of the restored area near structure #6 off Chestnut Ridge Road.
Photo on the right shows a restored area in the ROW off John Todd Way. 9/20/06.**

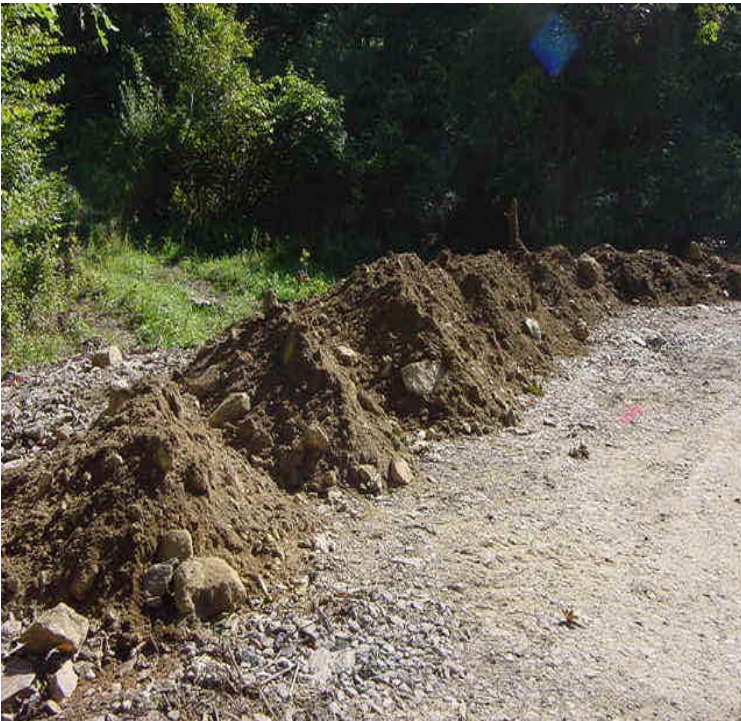
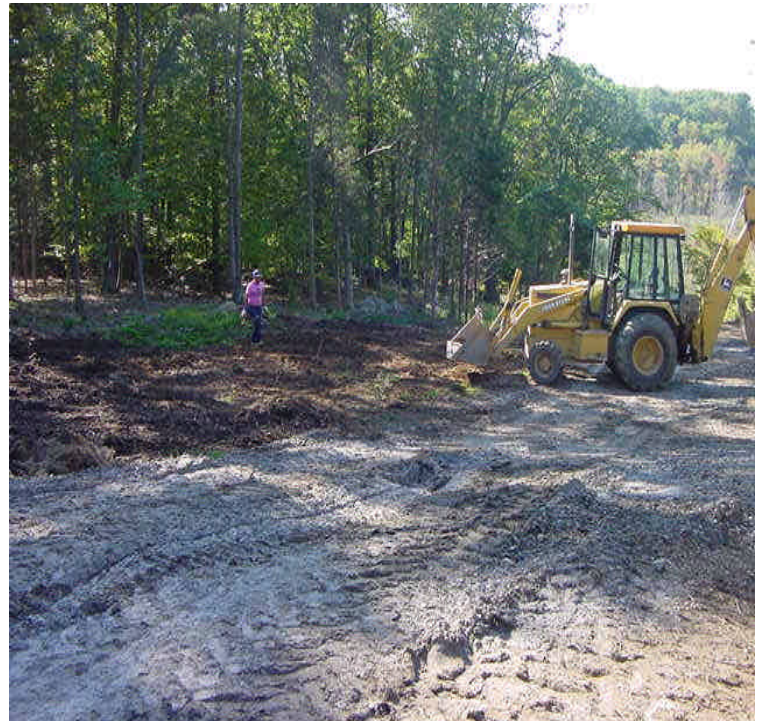
**Both photos show non-project related work performed by a private contractor. Photo on the left shows soil stockpiled along the edge of the driveway off John Todd Way. Photo on the right shows the contractor operating machinery in the recently restored area near structure #23.
9/20/06.**

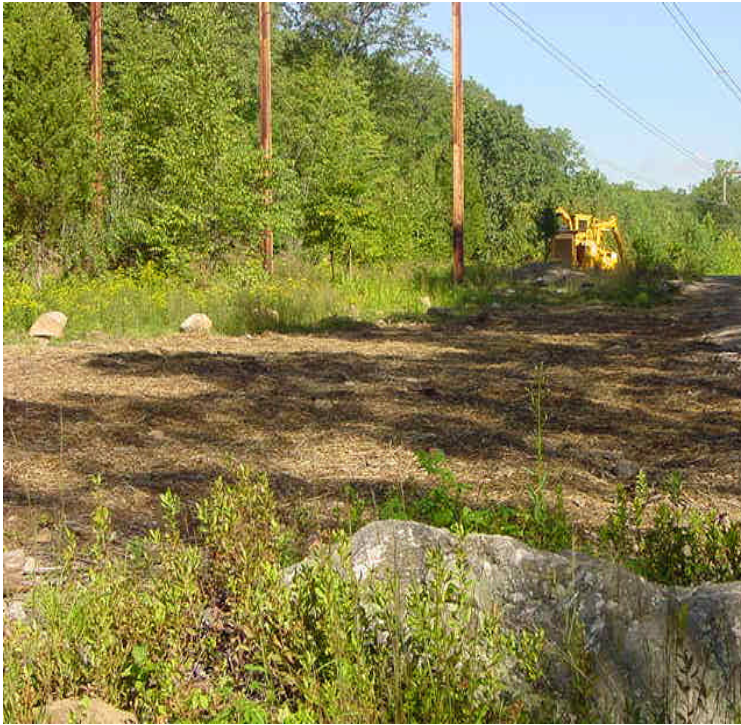
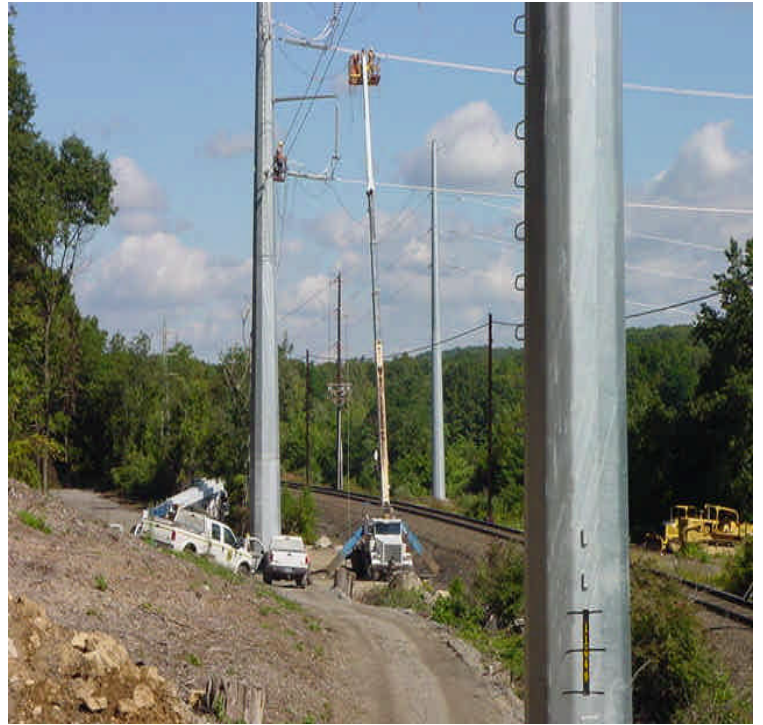
Photo on the left shows restoration activities continuing in the ROW off Costa Lane. (Norwalk Section): Photo on the right. shows crews installing wire spacers at structure #10048. 9/20/06.

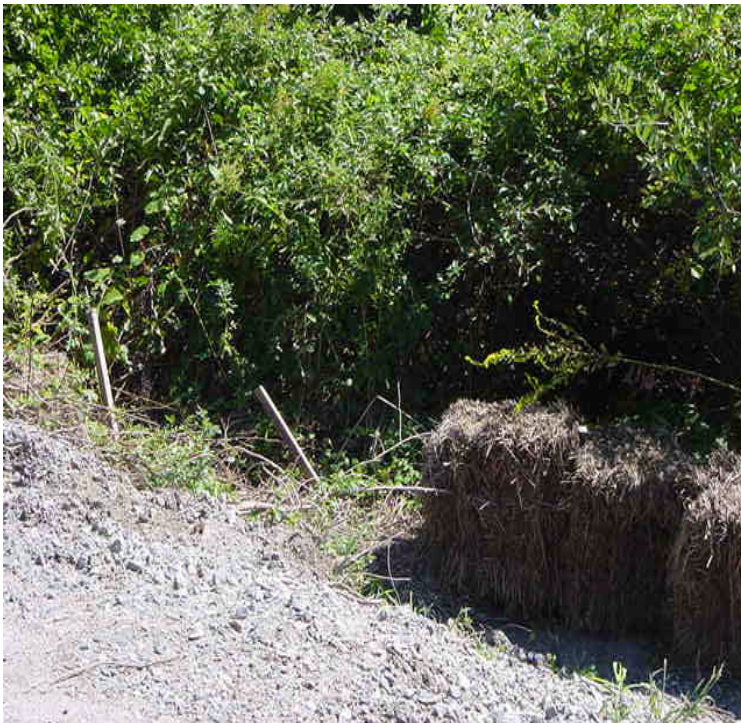
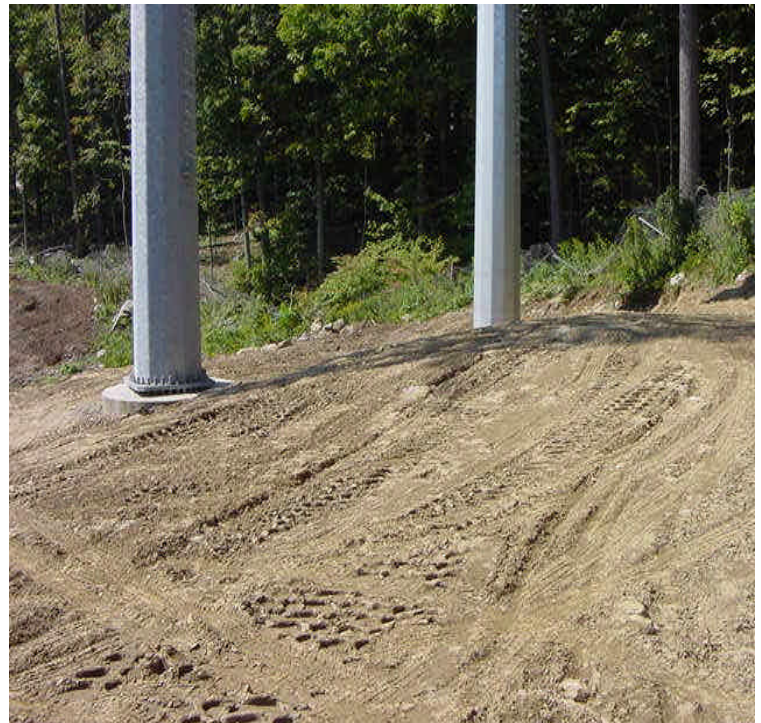
Photo on the left shows on the right. Shows the erosion controls deteriorating along the access road in the ROW off Kent Road (south). Photo on the right shows the newly graded area at structure #11064 in the ROW off North Seir Hill Road. This area still remains to be seeded 9/20/06.
